Below is a sample Damage Assessment Report of homes impacted by a tornado in Tennessee in December 2023. Following that is a sample Property Report of one of the homes.

XXX Hunters Trail, Hendersonville, TN 37075, USA

Event: Tornado

Collection Date: December 11, 2023

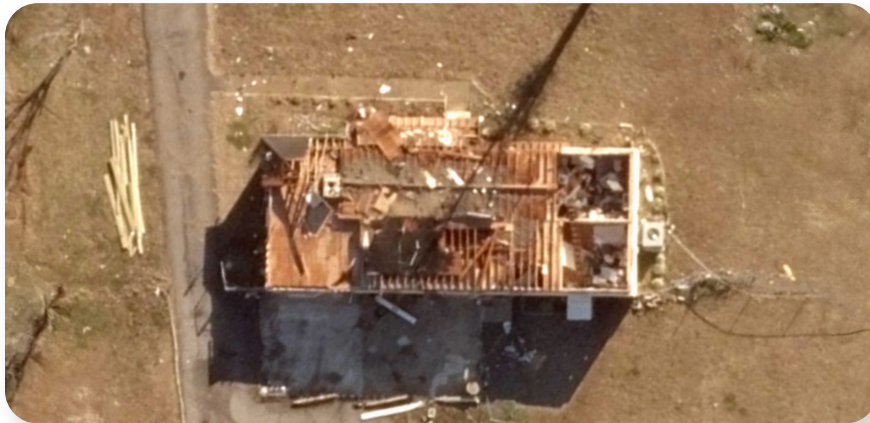
Damage Assessment

Catastrophe Score	100/100
Aprox. FEMA Score	6—Destroyed

Missing Roof Material	0%
Roof Structural Damage	89.87%
Tarp Coverage	0%
Discoloration	0%

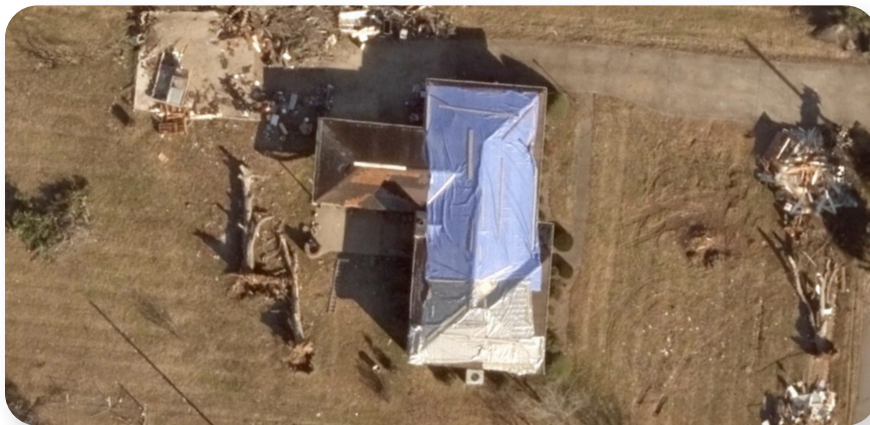
Damage Assessment

Catastrophe Score	51/100
Aprox. FEMA Score	3—Moderate

Missing Roof Material	2.49%
Roof Structural Damage	0%
Tarp Coverage	66.79%
Discoloration	7.35%

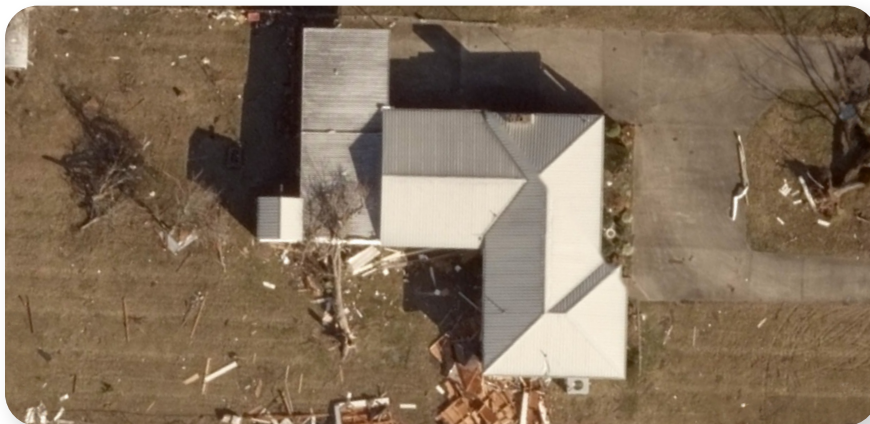
Damage Assessment

Catastrophe Score	0/100
Aprox. FEMA Score	None— No Damage

Missing Roof Material	0%
Roof Structural Damage	0%
Tarp Coverage	0%
Discoloration	8.04%

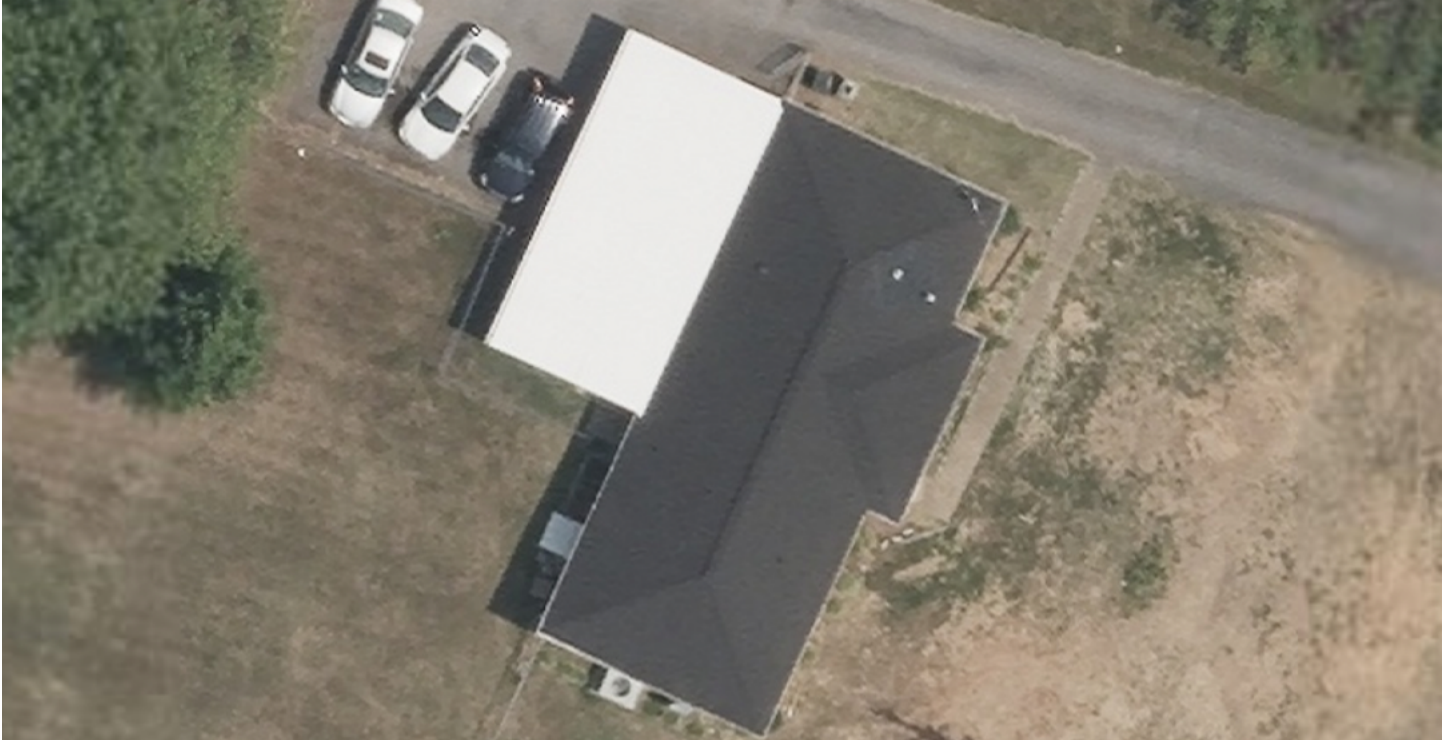
Primary Building: Roof Attributes

Roof shape	hip	Missing roof material	0%
Roof material	shingle	Roof tarp	0%
Roof condition	4/5	Debris	0%
Roof discoloration	0.98%		
Vent staining	0%		
Algae staining	0.98%		
Water pooling	0%
